IS IT LIVEABLE?

A mystery shop of private rental properties

Consumer Policy Research Centre and Tenants Victoria (2023),
Is it liveable? A mystery shop of private rental properties.

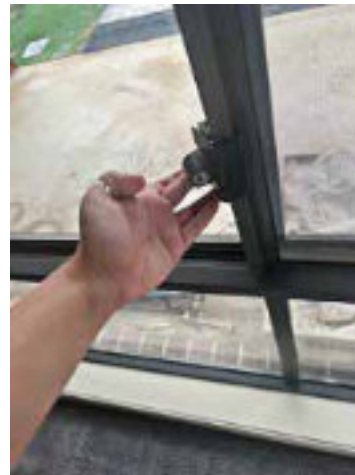
Two properties we viewed had issues with window locks. In one property, there were locks only on some windows: one window had a broken lock and some bedroom windows were missing a locking feature all together. The second property had an older-style bathroom window which could be opened, but had no latch, lock or bolt.

Image 3: broken window lock in Wyndham Vale, presenting a future security issue for a person renting the property.

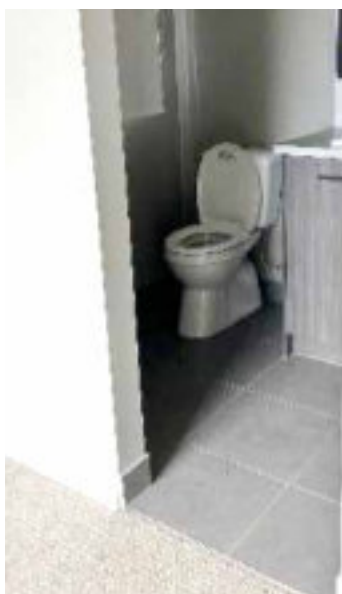
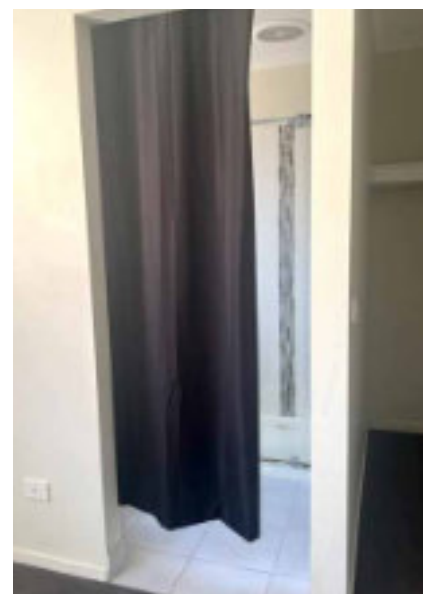
Mystery shoppers assessed these two standards via confirmation of the presence and availability of a toilet and a bathroom. All properties had bathrooms and toilets, but we did identify three toilets without a door, likely failing to meet the standard.

Images 4, 5 and 6: three bathrooms without doors, two with curtains provided as an alternative.

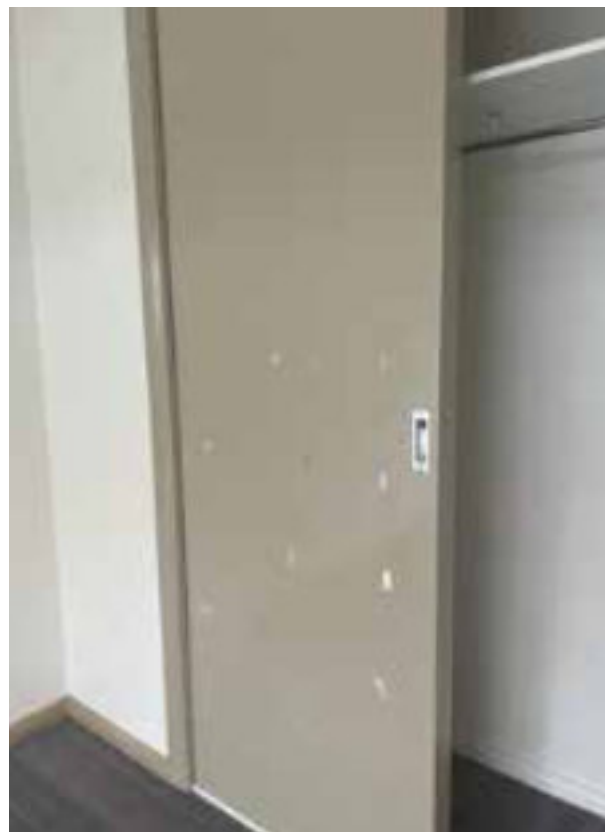
Looking at the minor issues, we found 16 properties with paint chips or paint damage. These issues are not required to be addressed under the minimum standards but do affect the visual quality of a home. Some paint damage was significant, with paint removed from large parts of walls or doors.

Images 7 and 8: examples of paint damage identified in the mystery shop

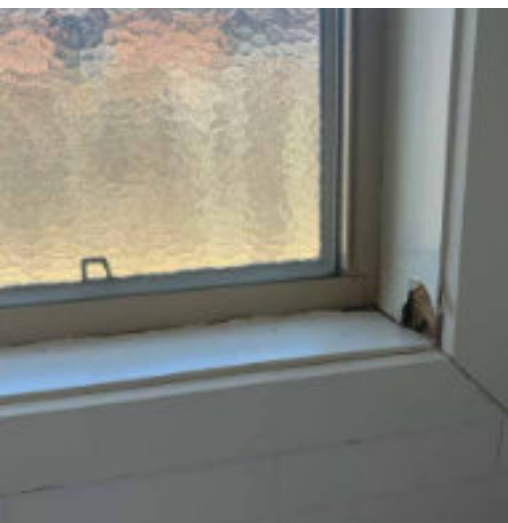
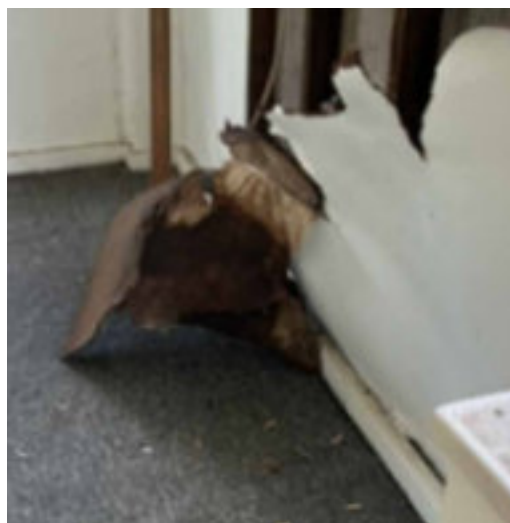
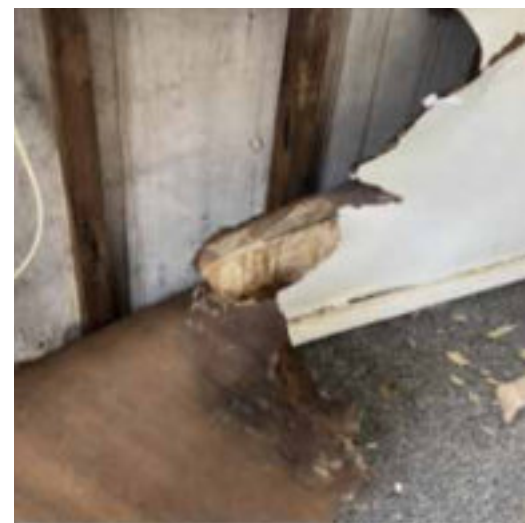
We found three homes with major holes in walls or window frames. These holes go beyond visual damage, making spaces within the property unusable or creating a safety hazard for renters. We also identified one issue with flooring that was so poor that a room would have been difficult to use.

In one home, the mystery shopper was told that there was water damage that the agent promised would be fixed before a new renter moves in. While it was positive that this promise

was made, the damage was so significant that it would have been difficult to fully resolve in a short period of time.

“Two areas were covered off due to water damage. One area was in the ceiling upstairs. The other area was downstairs in the living area... there appeared to be a leak in the wall downstairs and there was another leak in the ceiling upstairs which the realtor advised had mould in it.”

Images 11, 12 and 13: Examples of larger holes and water damage identified in the mystery shop

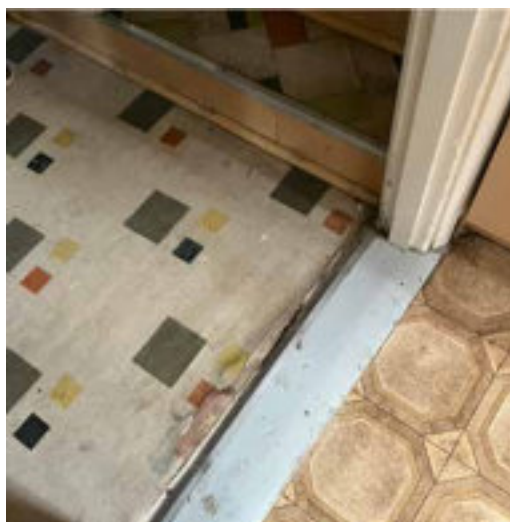
Images 14, 15 and 16: An example of damaged and uneven flooring from the mystery shop

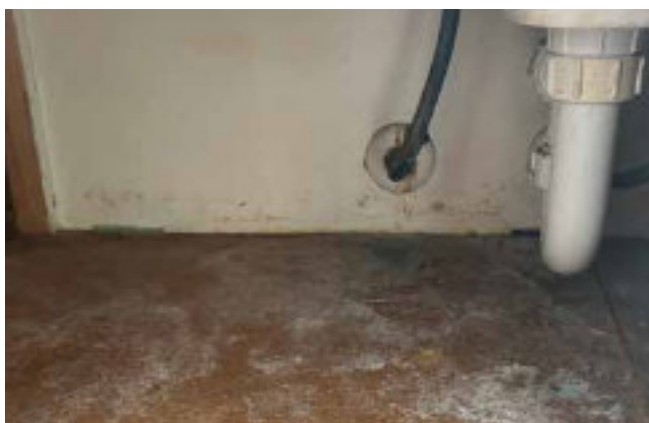
Image 17: Presence of water damage and mould in a property where the agent was unaware of the mould history

“The real estate agent advised they were unaware of any mould reports, even when I mentioned there was water damage and mould in the bathroom cupboard.”

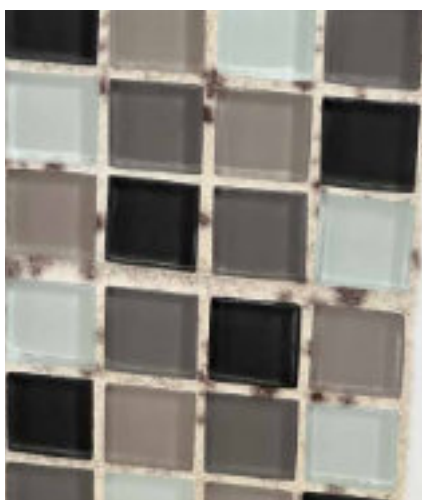
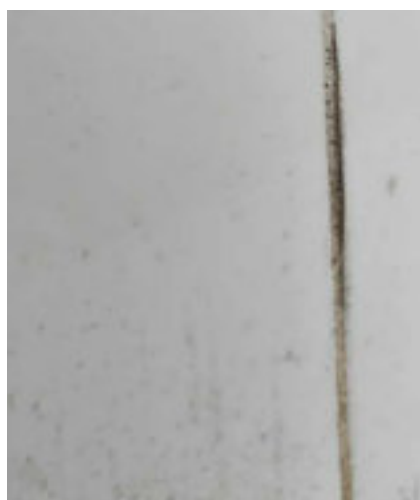
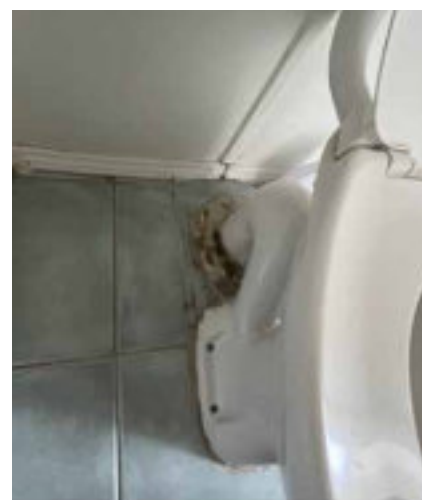
Our mystery shoppers found 91 of the 100 properties were free of mould. We identified nine properties as having visual signs of mould based on an examination of all accessible areas within the property. However, in some instances, it wasn't clear if the marks were mould, dirt or stains and consequently an additional three properties were given the benefit of the doubt and assessed as likely compliant.

Image 18: Three examples of mould identified in the mystery shop

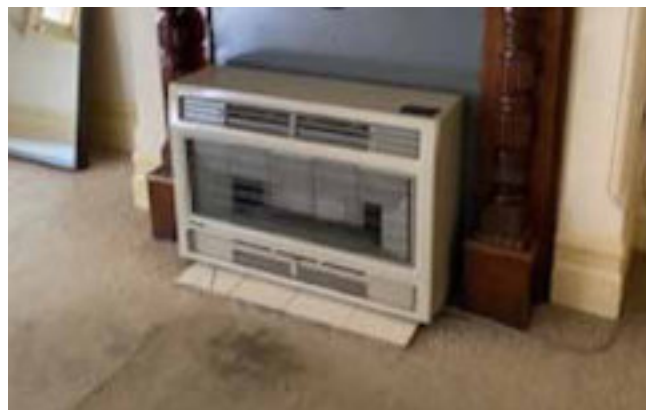
For the other 14 failures, a gas space heater or split system/heat pump was present, but the agent could not provide information about the energy efficiency of the unit. In some of these cases, the heater was clearly quite old and had not been updated in many years.

Image 21: One of the older heaters from an inspection in Bendigo

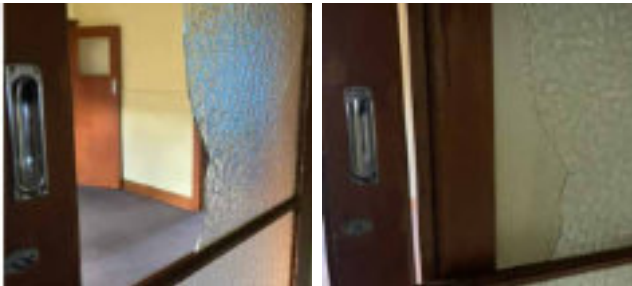
Images 22 and 23: Example of poor maintenance – broken glass on indoor doors

**** There was a broken glass pane in one of the interior door panels that could easily cut someone***

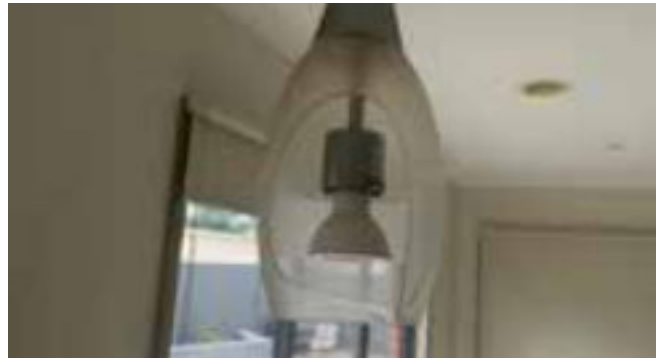
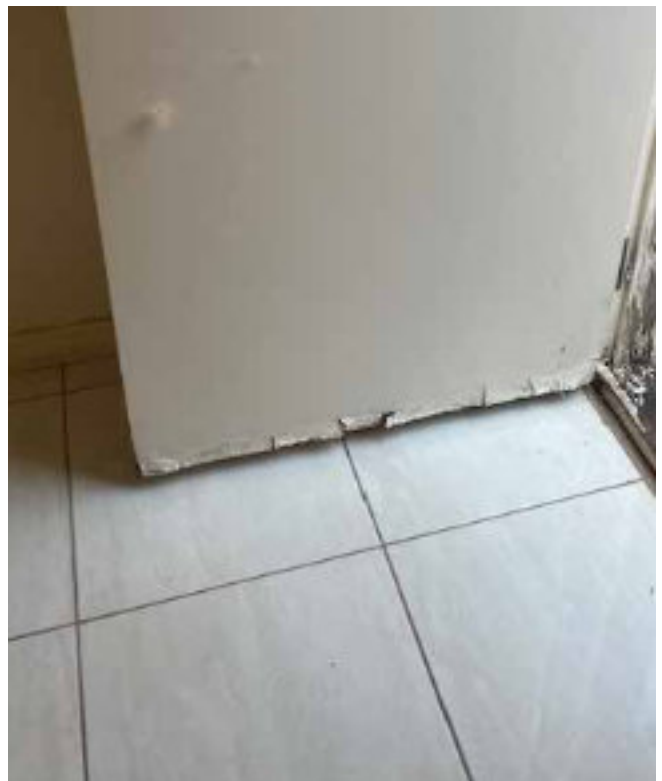
Images 26 and 27: Examples of poor maintenance- a broken light fitting and a damaged door

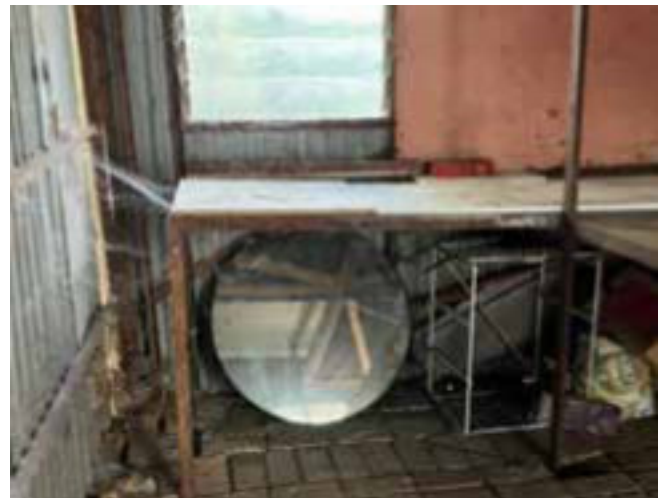
Images 28 and 29: Examples of debris found in untenanted properties in the mystery shop.
